## Columbia Manufacturing, Inc. Plating Operations Achieve Zero Wastewater Discharge

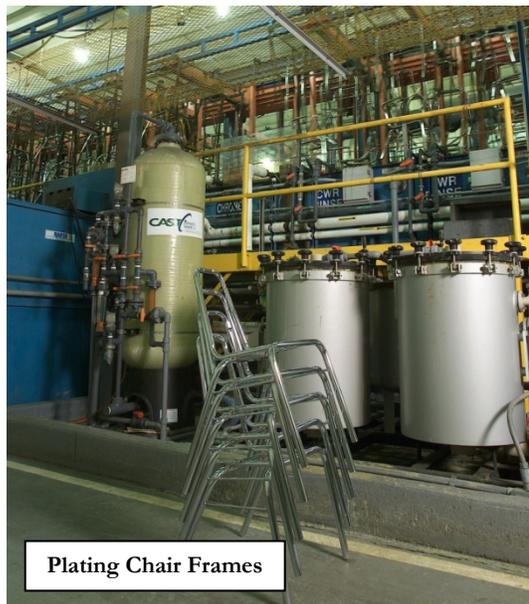
The reformatted plating operation integrated a new plating line, with drag-out recovery and counter-flow rinse tanks, and three CASTion vacuum distillation units for treating each of the segregated rinse water streams from the cleaner/acid line, nickel plating line, and chromium plating line.

Water from all three vacuum distillation units runs through an ion exchange system with the following steps: ultrafiltration, granular activated carbon, ion exchange, final filtration and ultraviolet sterilization. The resulting de-ionized (DI) water is reused on the plating line, resulting in a closed-loop process, where all industrial wastewater discharges to the sewer are eliminated.
